# Memorandum

**To:** Andrew Wang and Adam Green, Solar Reserve  
**From:** Steve Yarbrough, Tetra Tech EC, Inc.  
**Date:** December 22, 2010  
**Project:** Saguache Solar Energy Project  
**Subject:** Wetland Reconnaissance  
**Distribution:** Project File

## Reconnaissance Summary

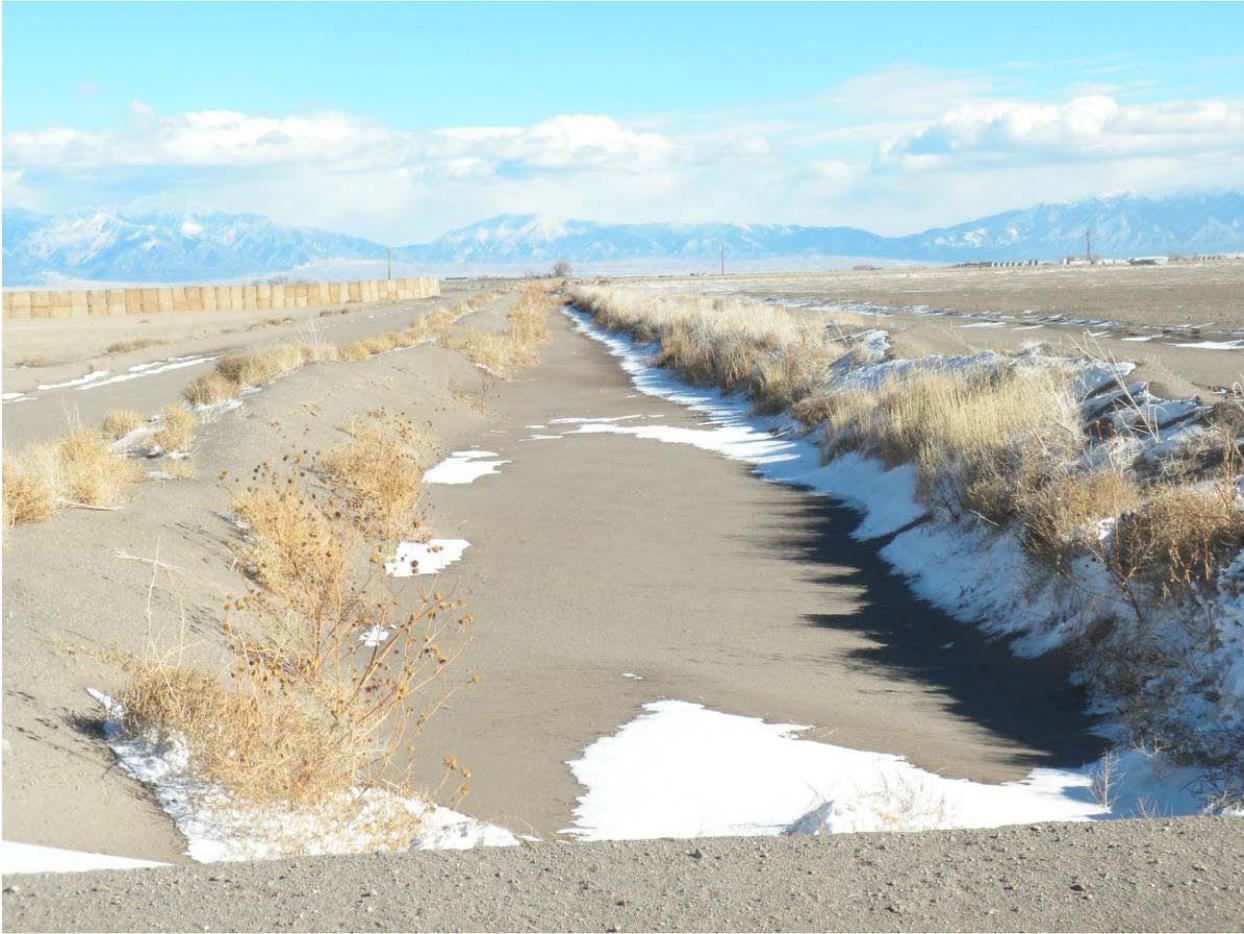
Photo 1: Looking east at the North Central Lateral Canal. This photo was taken near the center point of Section 20, T.41 N., R 9 E.

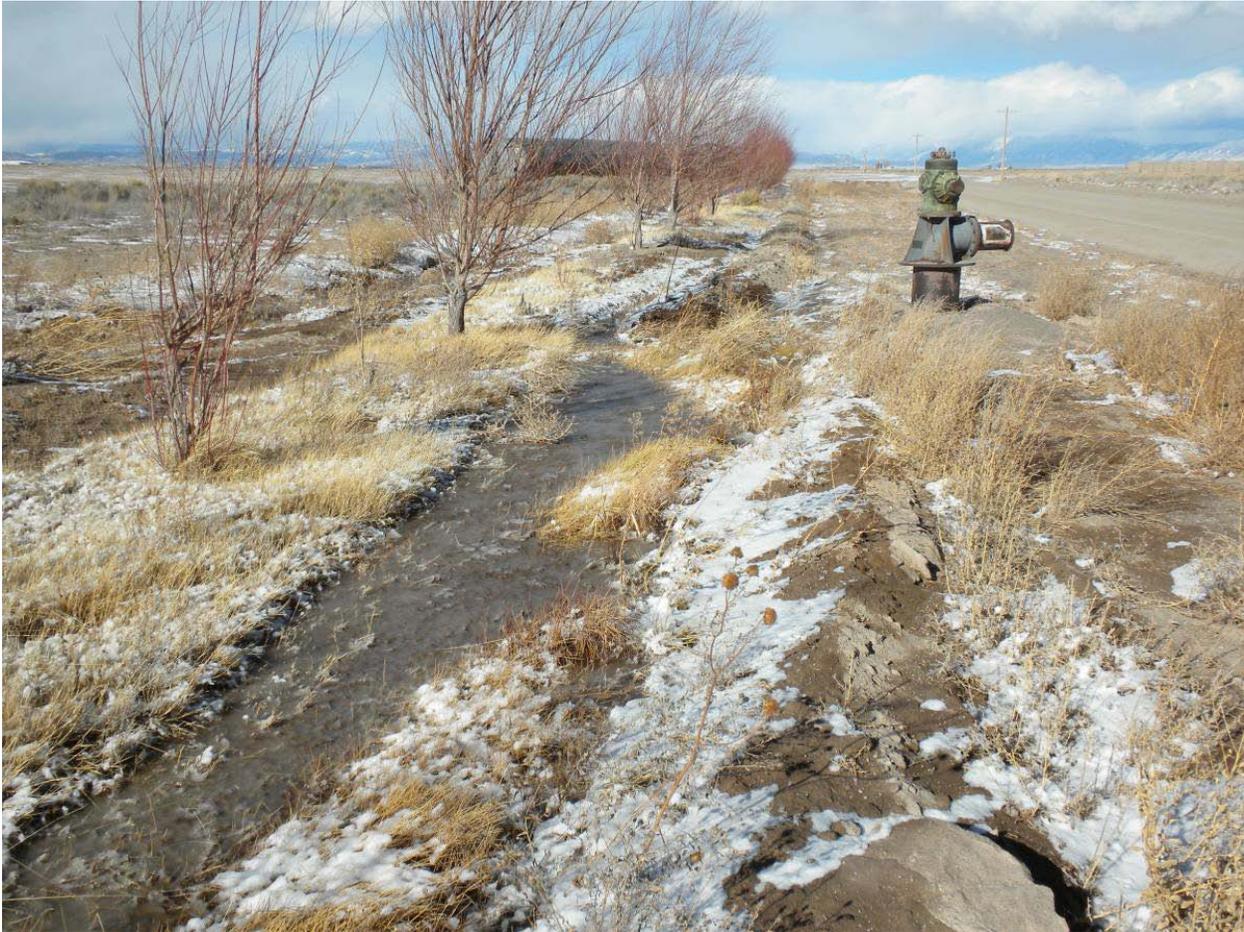
Photo 2: Looking north at NWI-2 with standing surface water on the left half of the photo. This area is mapped as a palustrine emergent wetland by the NWI. Its approximate size is 0.148 acres. There is a capped well on the right half of this photo. The photo was taken in the SE1/4 of the SE1/4 of the NW1/4, Section 17, T. 41 N., R. 9 E.

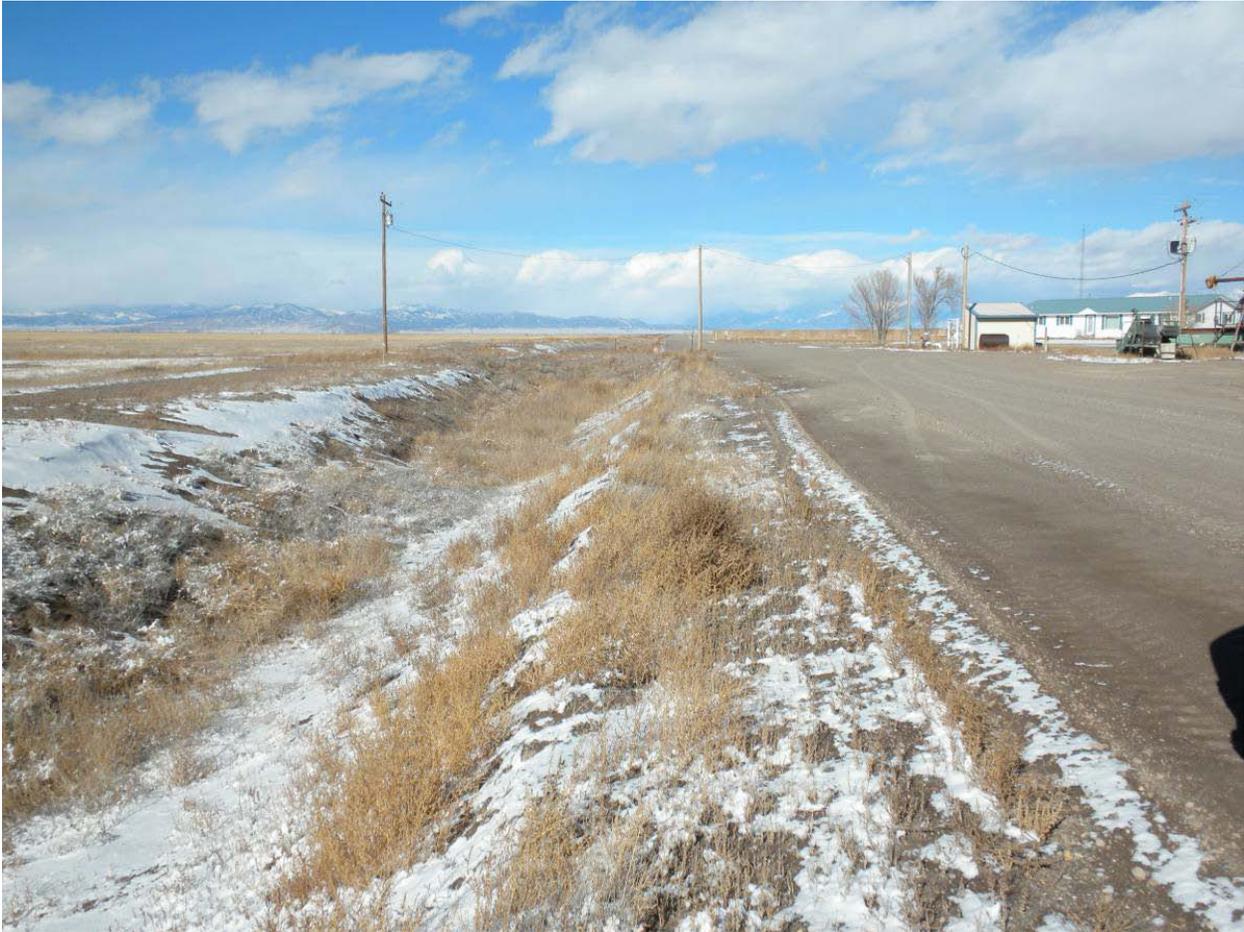
Photo 3: Looking north at an unnamed road-side ditch. There was no flow or standing water present. No wetland vegetation was noted. Location of this photo was SE1/4 of the SE1/4 of the SE1/4, Section 4, T. 41 N., R. 9 E.

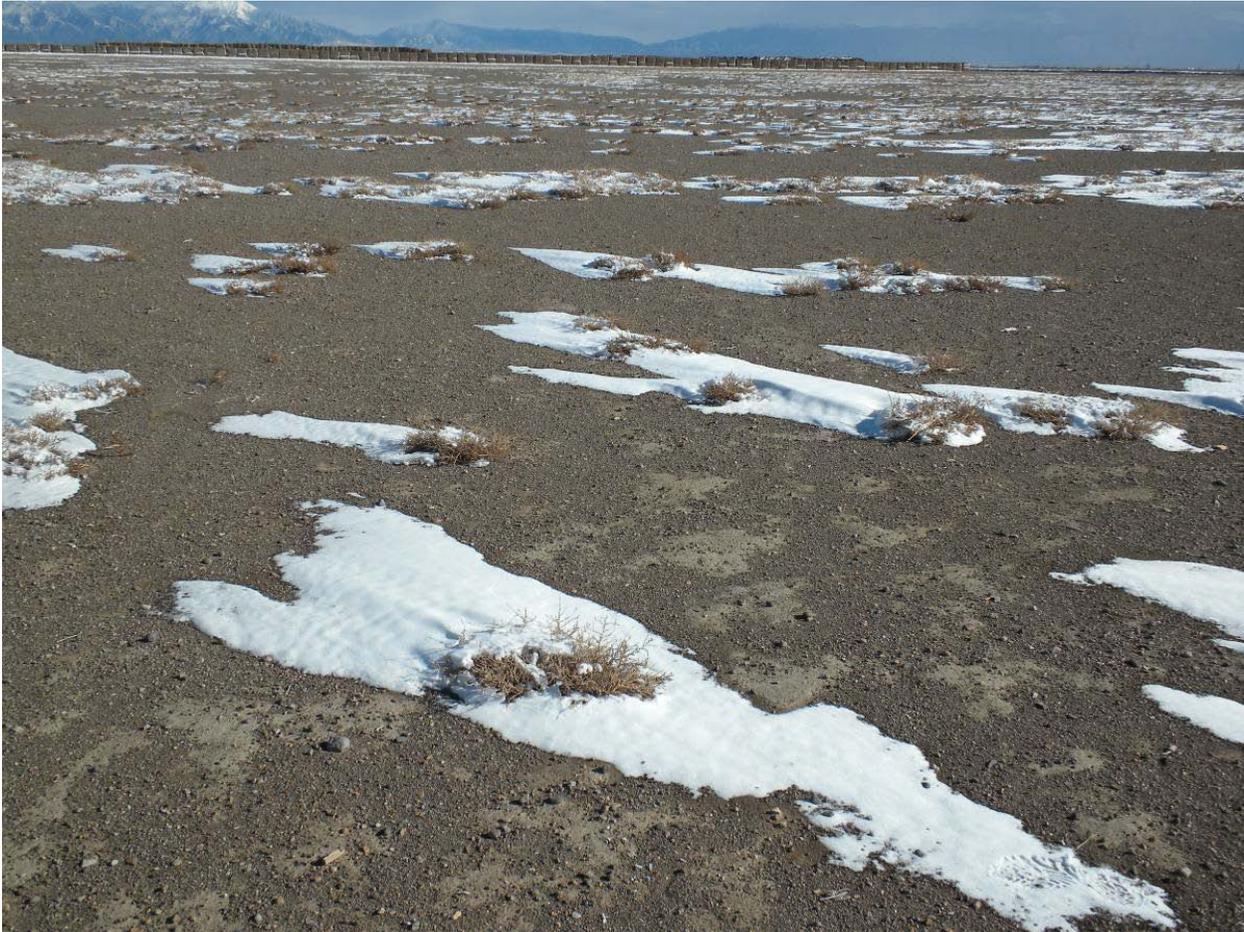
Photo 4: Looking southeast at the large, flat, unvegetated area mapped as NWI-5.. This area may be a shallow lake bed under wet conditions. The location of this photo was SW1/4 of the SW1/4, Section 11, T. 41 N., R. 9 E.

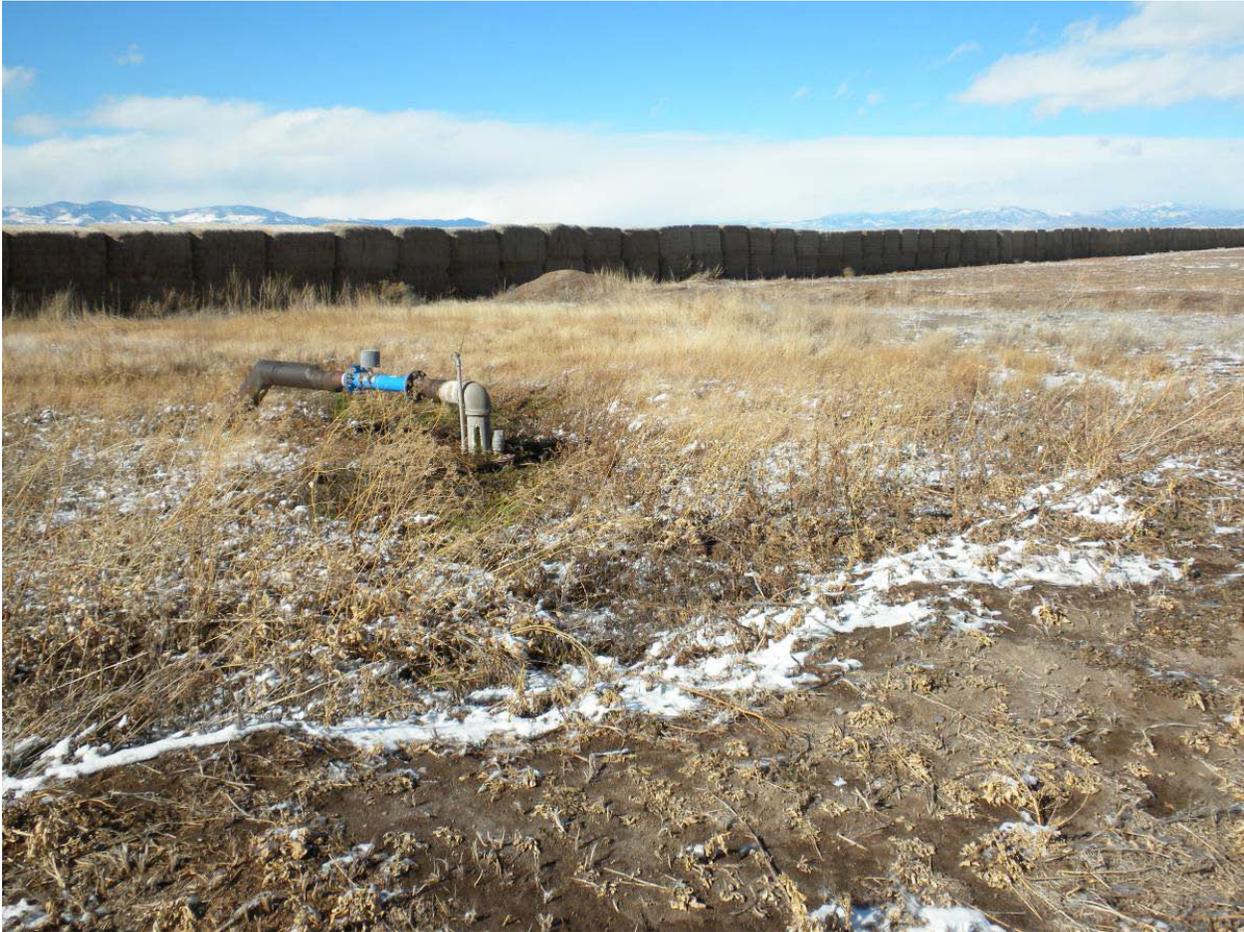
Photo 5: Looking northwest at the site of NWI-6. There was a flowing well here that is obviously capped and transmits water offsite via piping. The location of this photo was SE1/4 of the SE1/4 of the SW1/4, Section 11, T. 41 N., R. 9 E. Wetland vegetation, including rushes, bulrushes, and duckweed were observed. A large, flat, unvegetated area lies east of the well and probably represents a shallow lake bed under wet conditions.

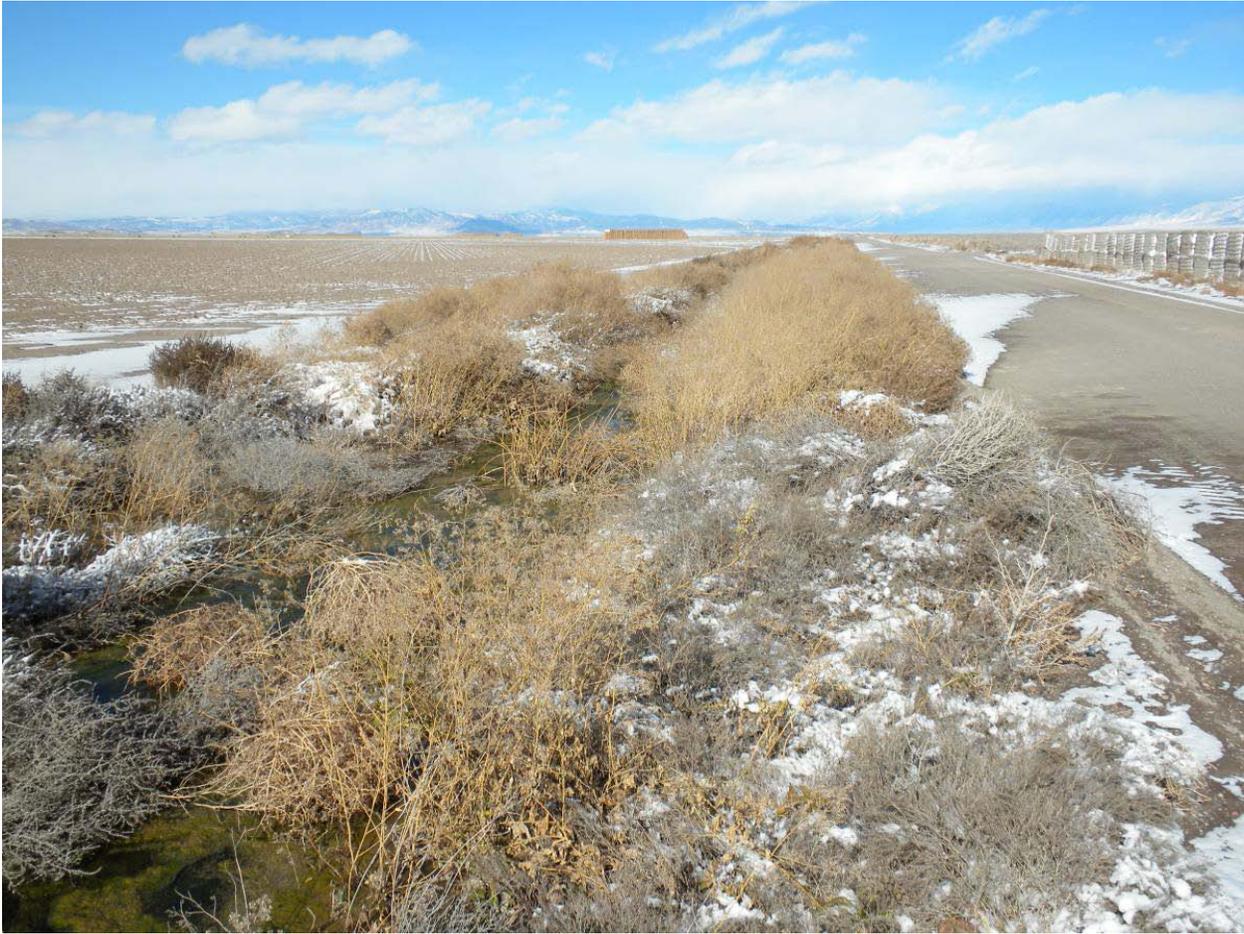
Photo 6: Looking north along Gibson Ditch. 57 Road is to the right in the photo. This photo was taken in the SE1/4 of the SE1/4 of the SE1/4, Section 10, T. 41 N., R. 9 E. Flow appeared to be to the north at this location.

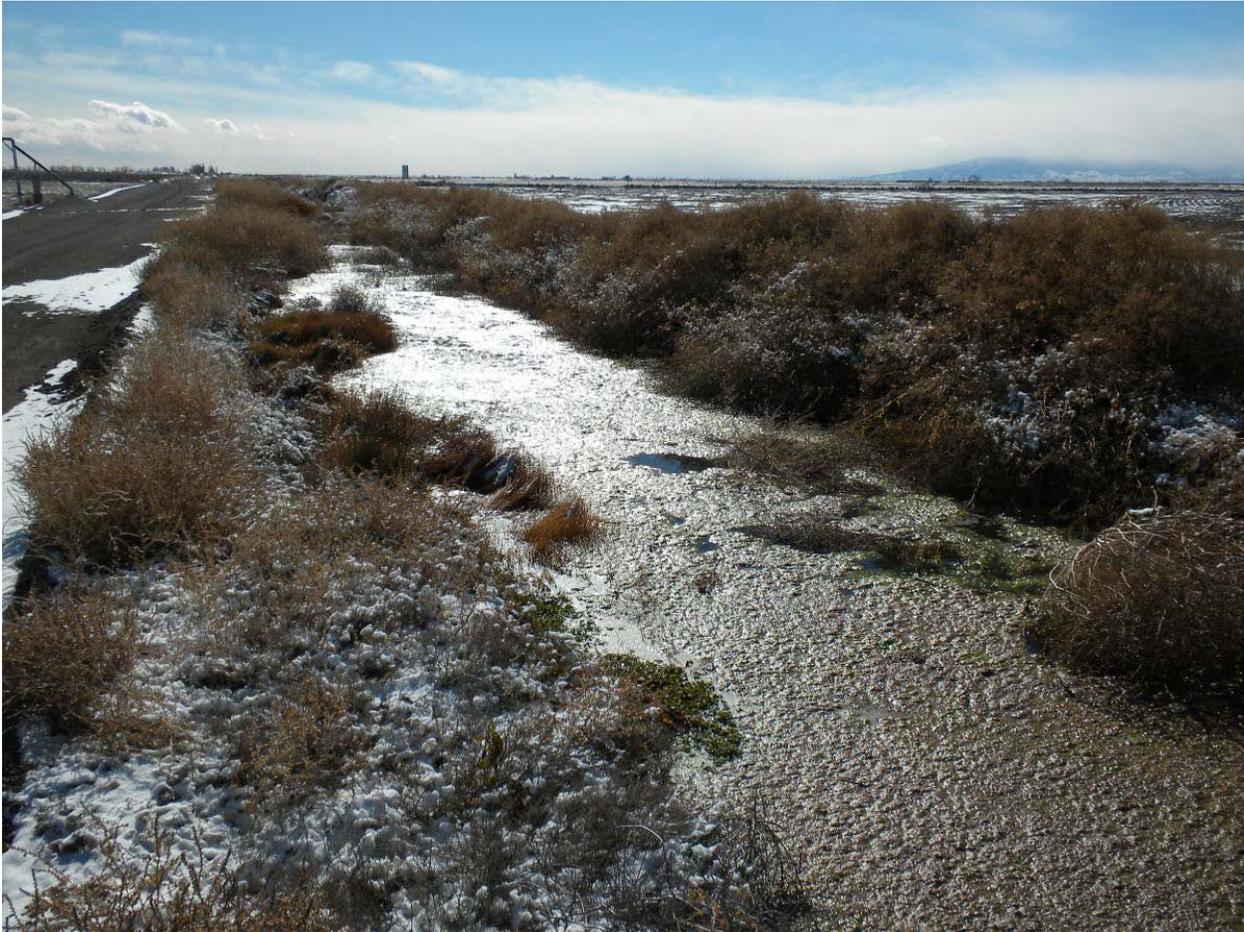
Photo 7: Looking south along Gibson Ditch. This ditch runs north/south in this area. This photo was taken in the SE1/4 of the SE1/4 of the SE1/4, Section 10, T. 41 N., R.9 E.

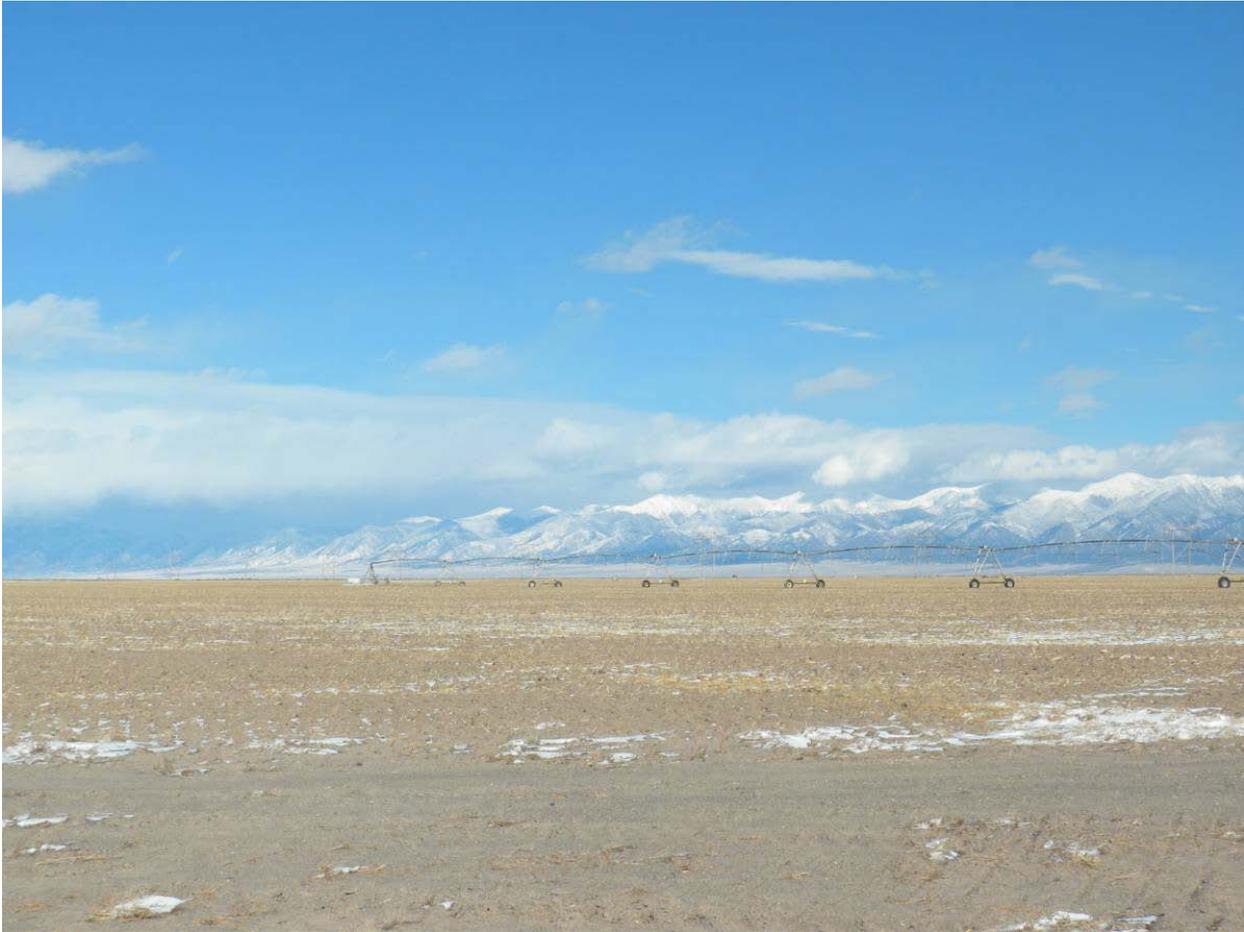
Photo 8: Looking north-northeast over a center-pivot irrigated field, characteristic of much of the site. Location is SW1/4 of the SE1/4 of the SW1/4, Section 4, T. 41 N., R. 9 E.

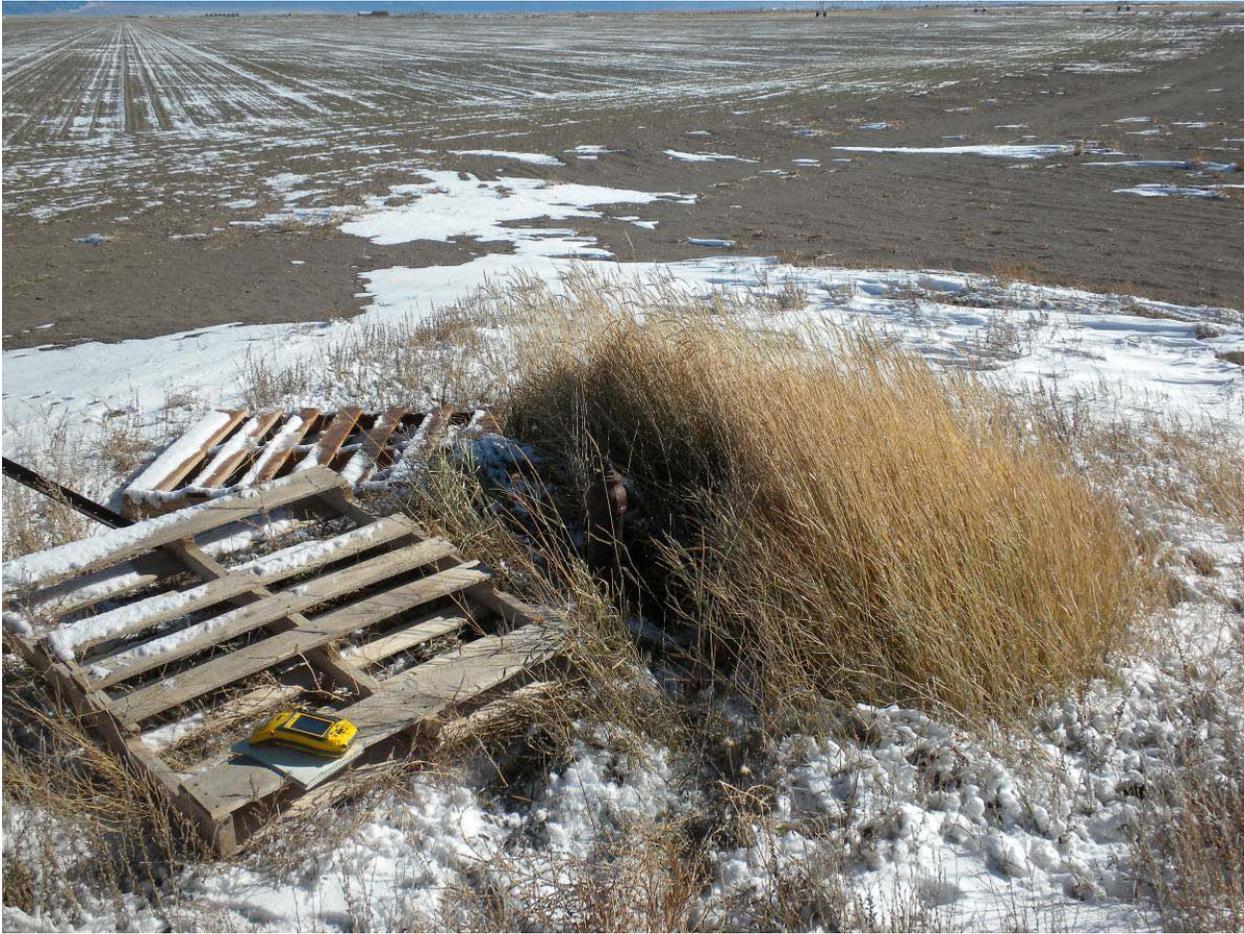
Photo 9: View of the site of a capped artesian well in SW1/4 of the SW1/4 of the NW1/4, Section 8, T. 41 N., R. 9 E. No wetland vegetation was documented.

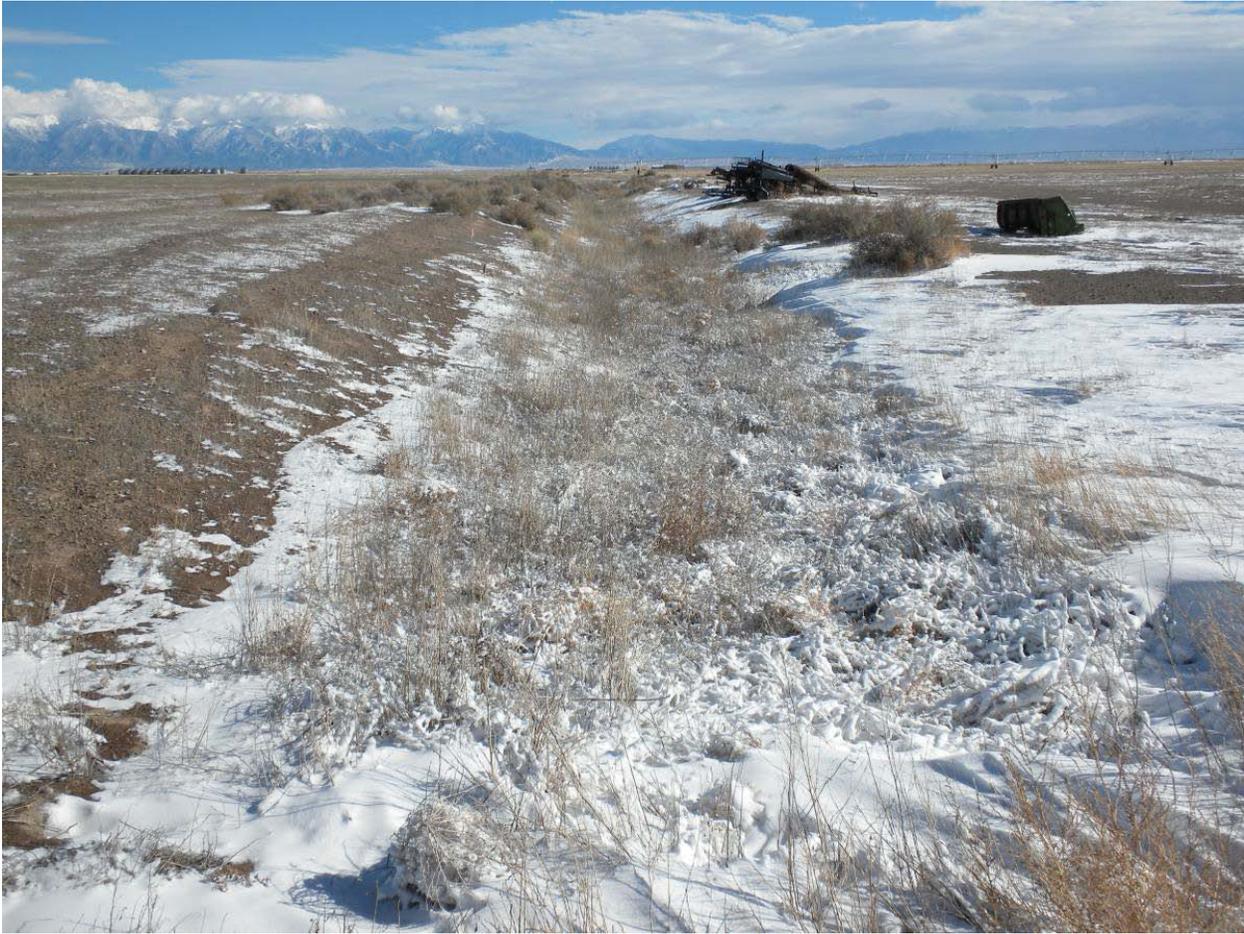
Photo 10: Looking east at an unnamed ditch. It is obviously snow-filled, but the vegetation present here did not appear adapted for life in saturated soil conditions. The photo was taken 0.50 mile north of the North Lateral Canal, in the SW1/4 of the SW1/4 of the NW1/4 of Section 8, T. 41 N., R. 9 E.

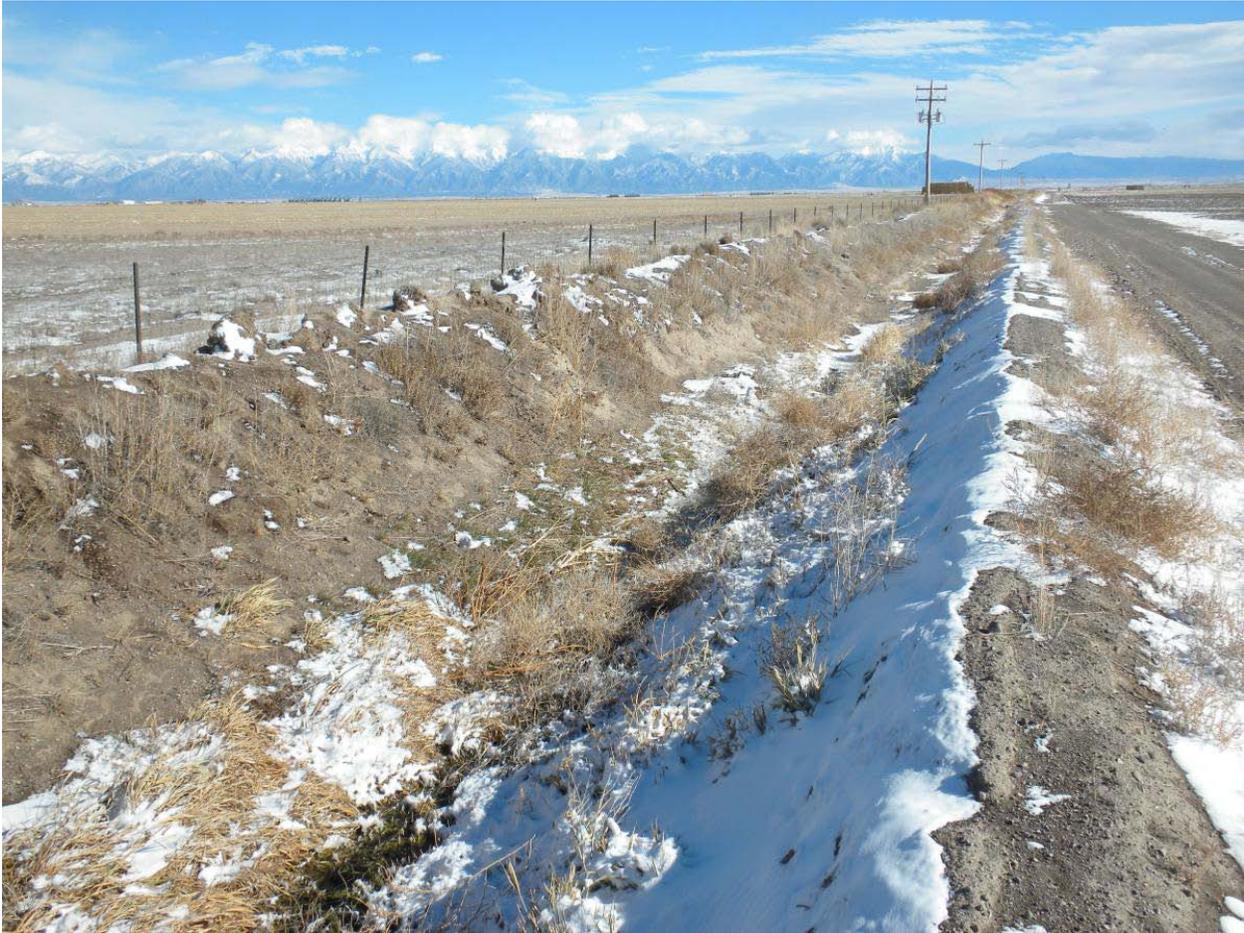
Photo 11: Looking east the North Lateral Canal. E. Road is to the right in the photo. Photo location was SE 1/4 of the SW 1/4 of the SE 1/4 of Section 7, T. 41 N., R. 9 E. There was documentation of the hydrophytic grass species Reed canarygrass in this canal bottom. Small areas of pooled surface water were documented, but there was no observation of flow in the canal.
